# **Test Report**

Document No.	00782-21-0416_DRAFT Copy No. 1 Number of pages 42
Apparatus	Three pole switch-disconnector in horizontal design
Designation	TES-00/800 TES-1/800
Serial Number	Test samples
Manufacturer	THS Componentes Elétricos Ltda Rua Irineu Dias da Rosa, 25 Chac 3 Marias - Sorocaba - SP CEP: 18105-310 - BRAZIL
Client	THS Componentes Elétricos Ltda Rua Irineu Dias da Rosa, 25 Chac 3 Marias - Sorocaba - SP CEP: 18105-310 - BRAZIL
Date(s) of test(s)	06 to 11 August 2021
Tested by	IPH Institut "Prüffeld für elektrische Hochleistungstechnik" GmbH Landsberger Allee 378A 12681 Berlin GERMANY
	RAFailonon
The apparatus, con	structed in accordance with the description, drawings and photographs
IEC 60947-3: 2020	
The results are documented The document applies only t with the Manufacturer.	in this test report. The ratings assigned by the Manufacturer are listed on the ratings page. o the apparatus tested. The responsibility for conformity of any apparatus having the same designations with that tested rests

Description		Rating	Verified
Rated operational voltage	$U_{e}$	800 V	
Rated insulation voltage	Ui	1000 V	х
Rated impulse withstand voltage	$\mathbf{U}_{imp}$	8 kV	х
Rated

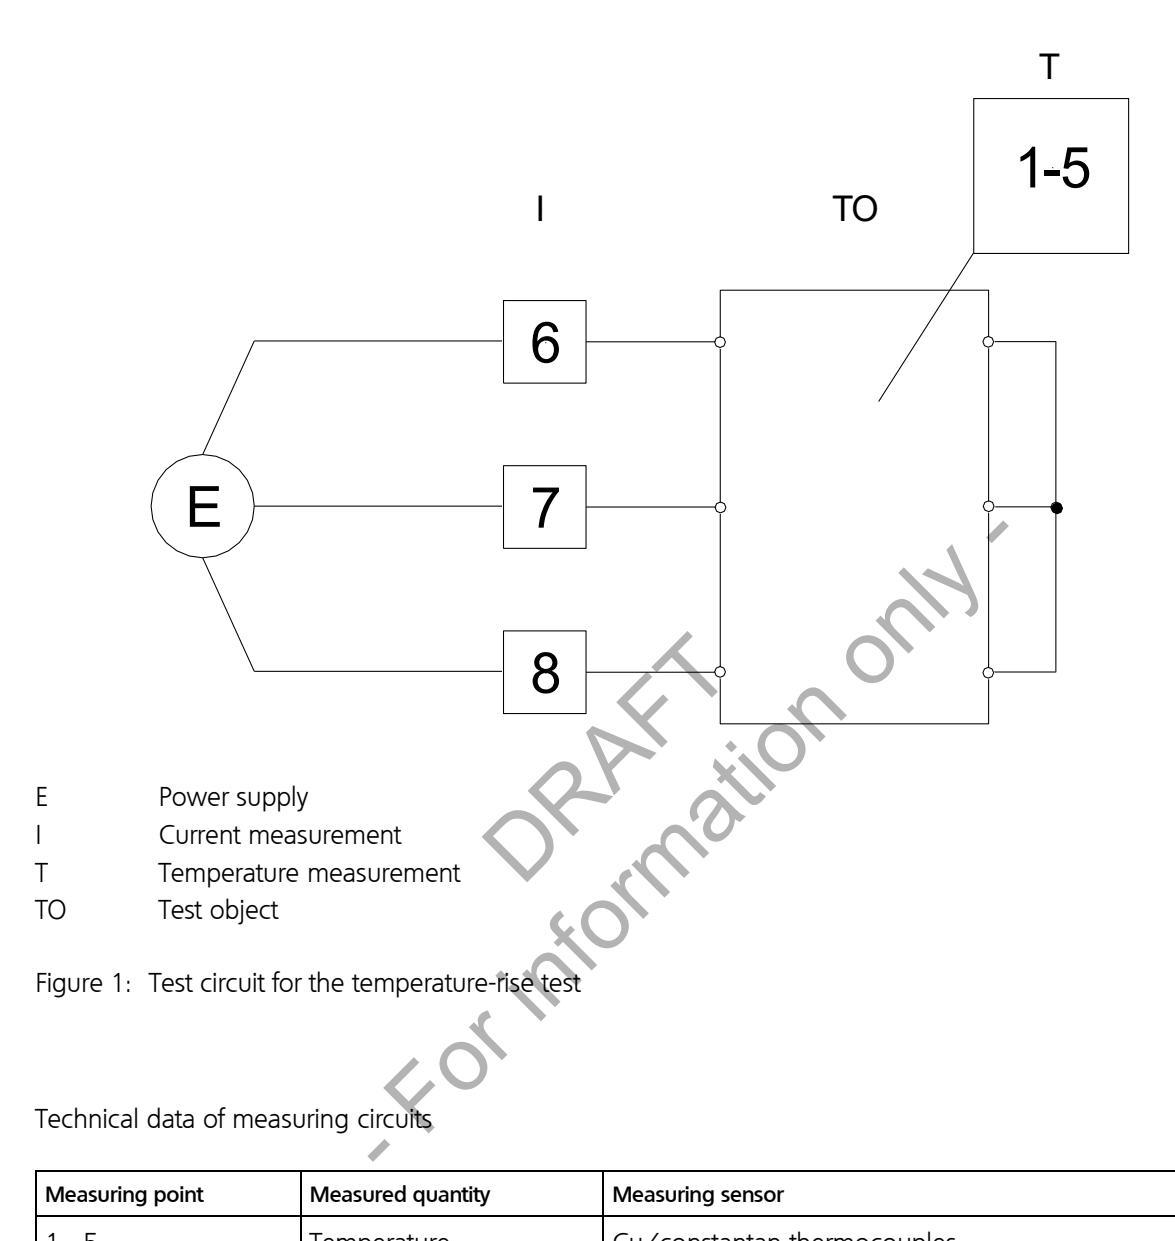
#### 4.1.5 Test and measuring circuits

Measuring point Measured quantity		Measuring sensor		
1 - 5	Temperature	Cu/constantan thermocouples		
6	Test current L1 Rogowski coil, integrator			
7	Test current L2	Rogowski coil, integrator		
8	Test current L3	Rogowski coil, integrator		
Measuring instruments: Measuring points 1 - 5: ALMEMO® 5690-2 XU Measuring points 6 - 8: Digital Display SPE

Test current TES-00/800:	160 A, three-phase
Test current TES-1/800:	250 A, three-phase
Test frequency:	50 Hz
4.6.4 Test arrangement	
See Sub-clause 4.1.4, Sheet 7	Orona
4.6.5 Test and measuring circu	its
See Sub-clause 4.1.5, Sheet 8	or

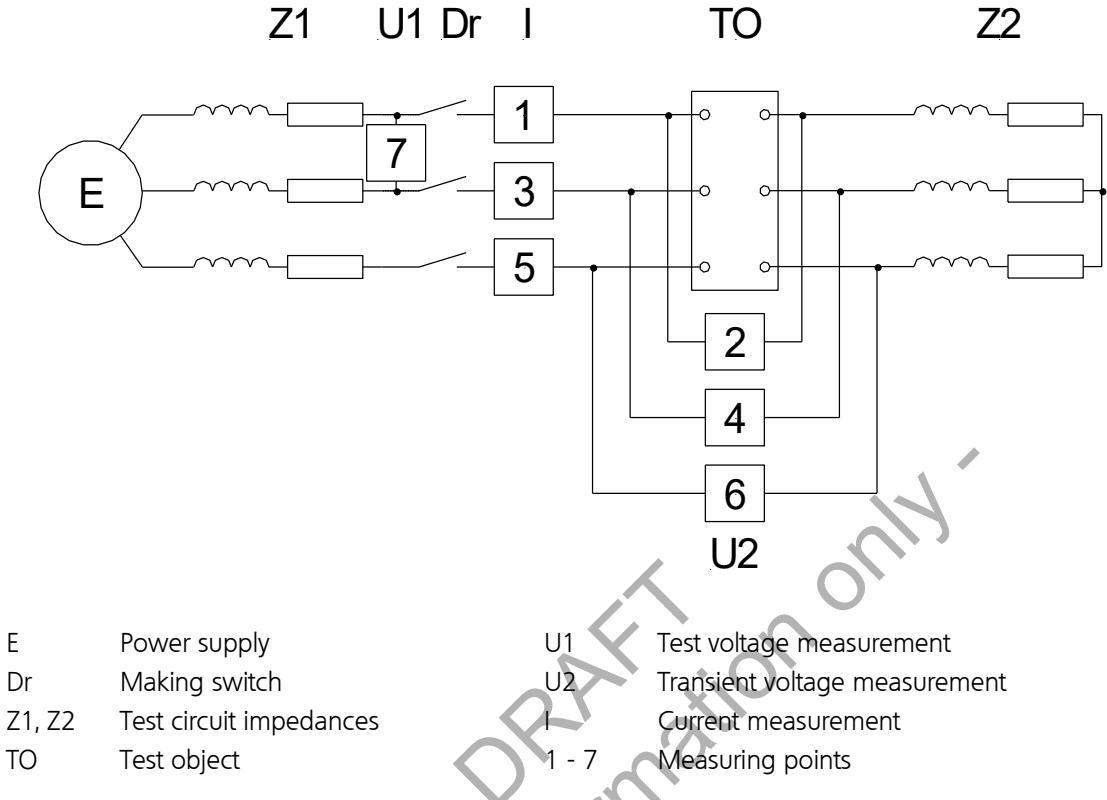
Figure 2: Circuit for the test of making and breaking capacities

Measuring point	Measured quantity	Measuring sensor				
1	Current L1	Shunt				
3	Current L2	Shunt				
5	Current L3	Shunt				
2	Voltage across pole L1	RC divider				
4	Voltage across pole L2	RC divider				
6	Voltage across pole L3	RC divider				
7	Test voltage	Voltage transformer				
Measuring instruments: Measuring points 1 - 6: BAKKER transient recorder with BE 256 A/D transducers Measuring point 7: Digital voltmeter

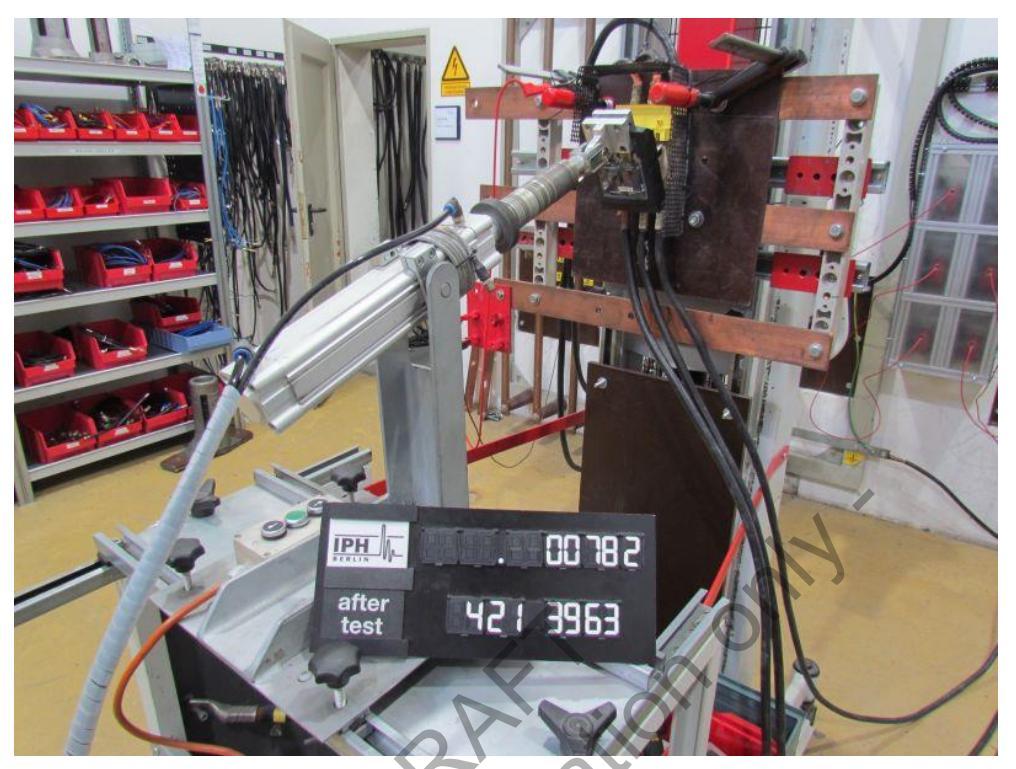
Photo 1: Test object TES-00/800 after the verification of making and breaking capacities

OK - The test object was able to make and break properly.

Immediately after the test of making and breaking capacities, the switching device was capable of properly opening and closing during a no-load operation. The force required for opening measured after the test was 66 N and did not exceed the permissible maximum value of 400 N (one-hand operation, table 17 of IEC 60947-1).

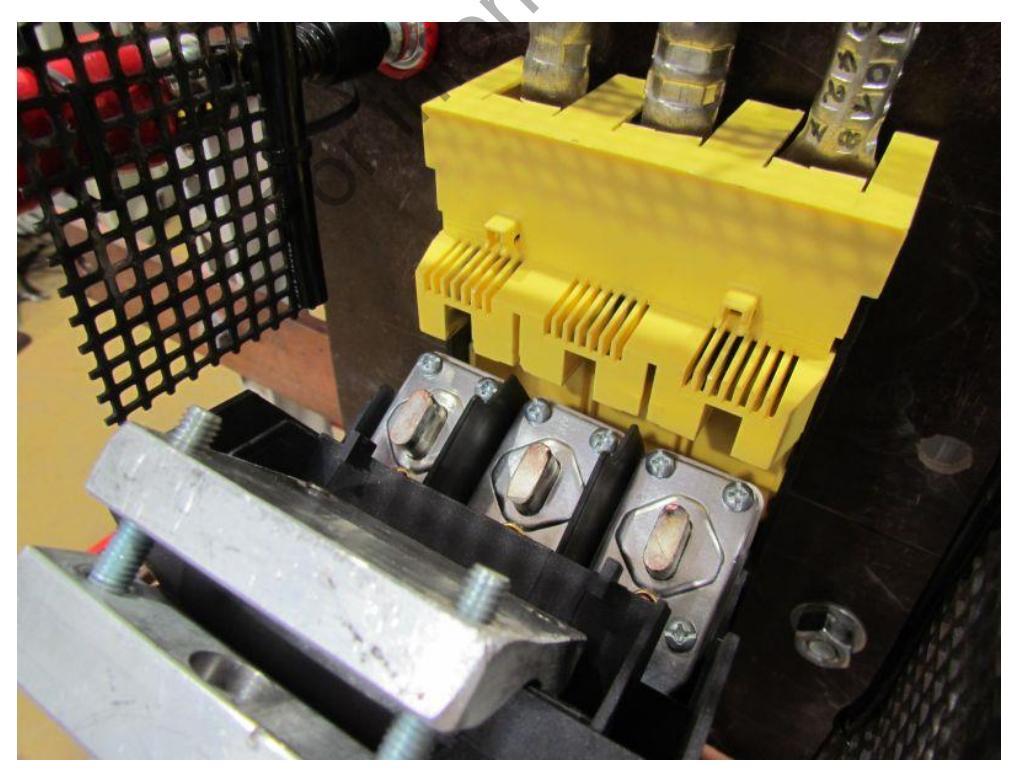
Photo 2: Test object TES-00/800 after the verification of making and breaking capacities

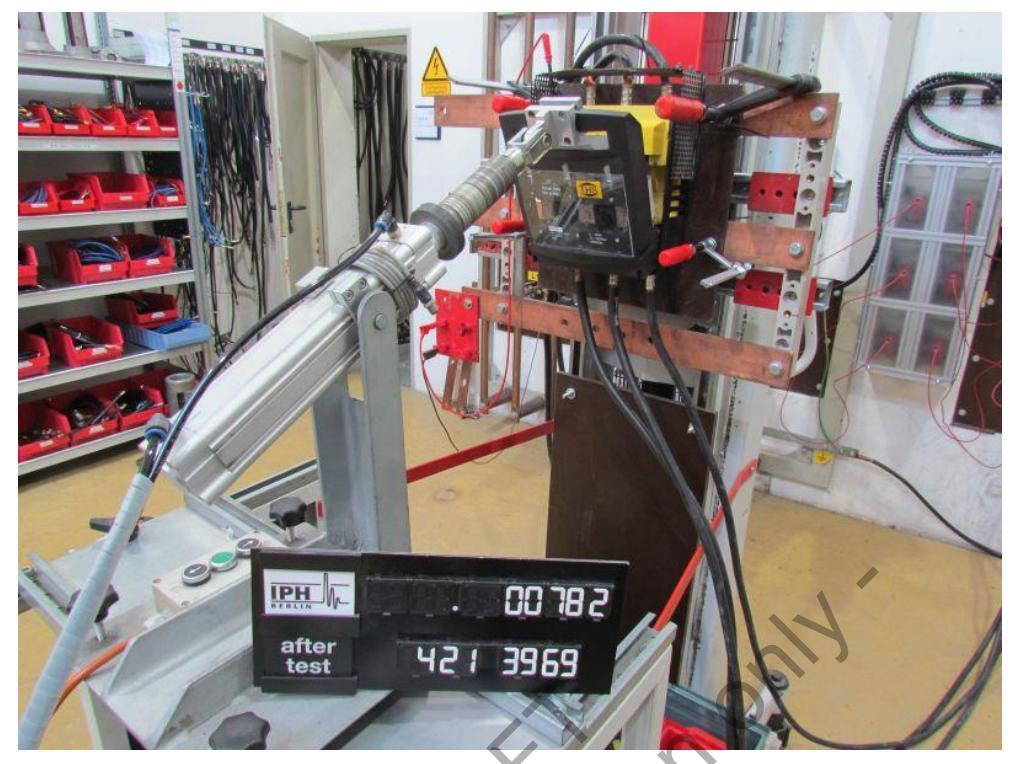
Photo 3: Test object TES-1/800 after the verification of making and breaking capacities

OK - The test object was able to make and break properly.

Immediately after the test of making and breaking capacities, the switching device was capable of properly opening and closing during a no-load operation. The force required for opening measured after the test was 121 N and did not exceed the permissible maximum value of 400 N (one-hand operation, table 17 of IEC 60947-1).

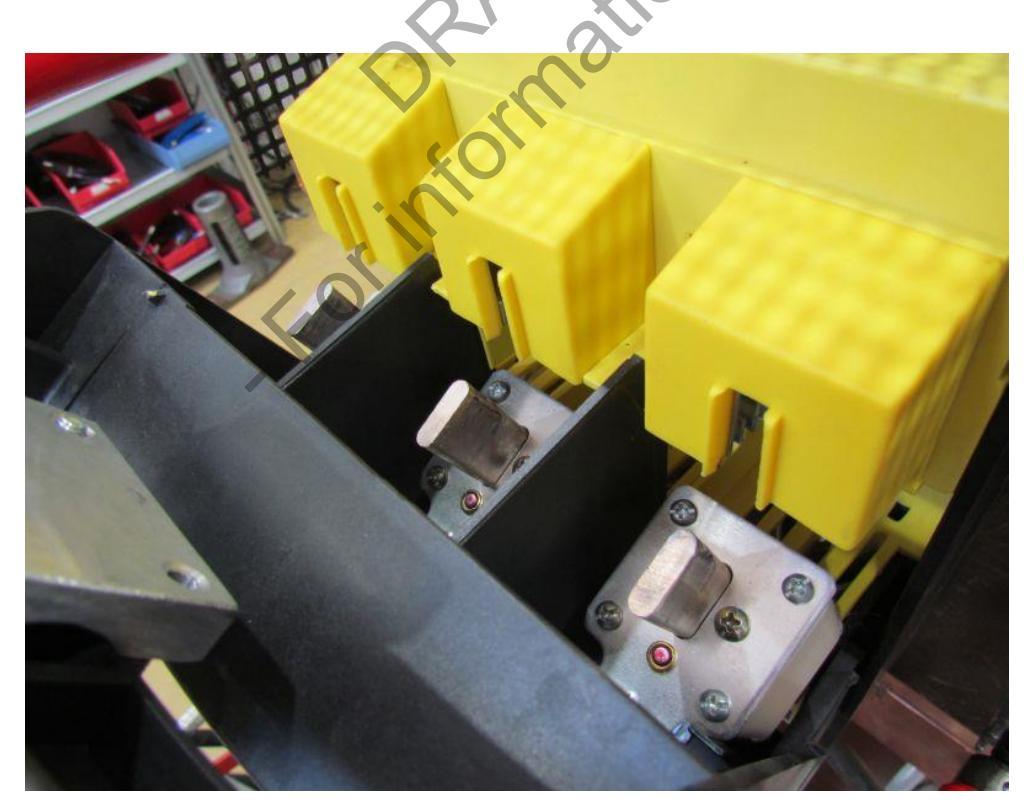
Photo 4: Test object TES-1/800 after the verification of making and breaking capacities

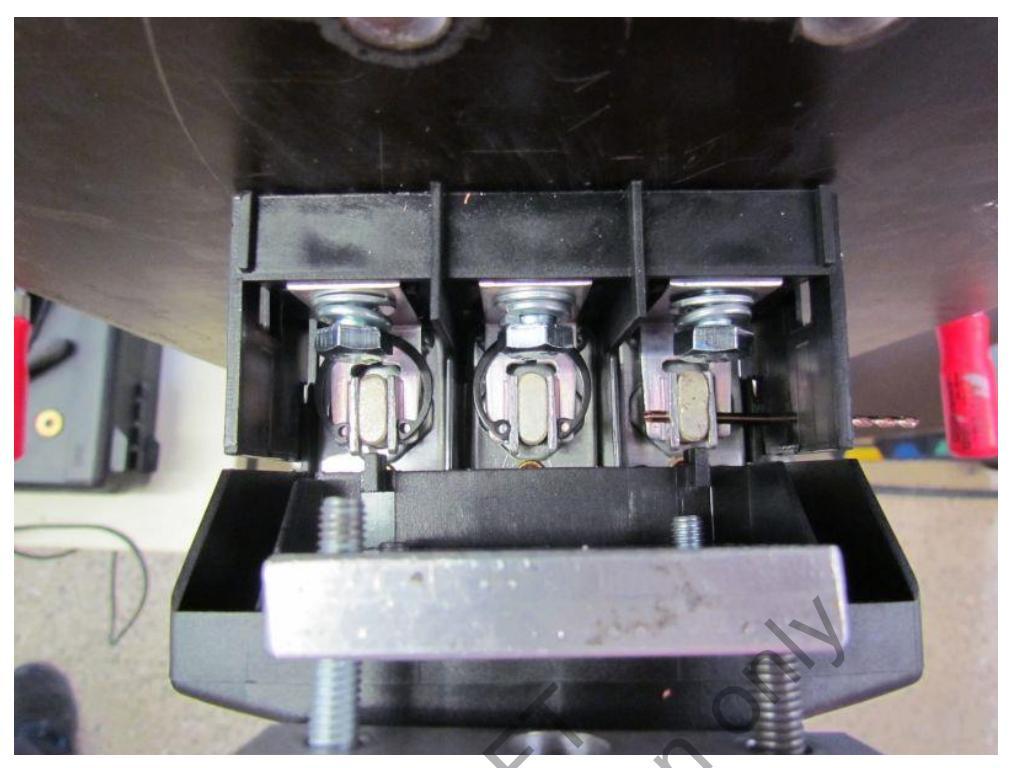
Photo 5: Test object TES-00/800 before the verification of the strength of actuator mechanism

The force F necessary for opening the test object was measured before the strength of the actuator test and is 52.3 N for TES-00/800 and 133.7 N for TES-1/800.

The actuator of TES-00/800 was subjected to the test force of 157 N (3 x F) according to IEC 60947-1, table 17 (one-hand operation). The force was applied without shock to the actuator in a direction to open the contacts for a period of 10 s.

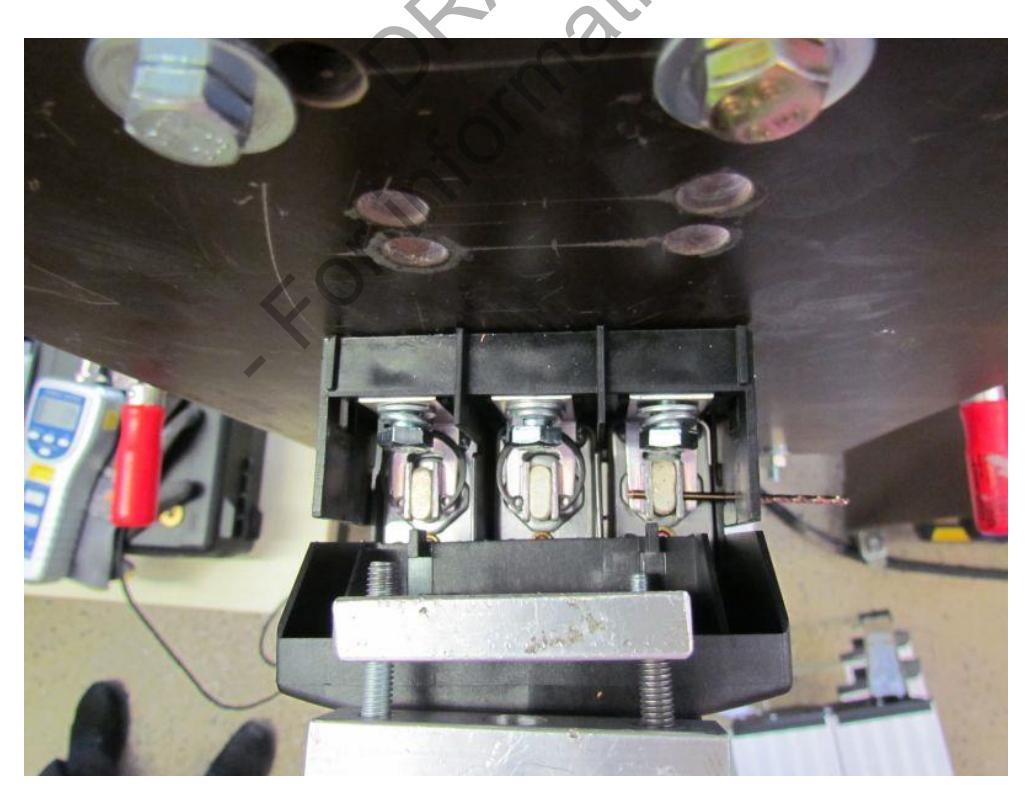
Photo 6: Test object TES-00/800 after the verification of the strength of actuator mechanism

After the test of strength of actuator mechanism no damage was found on the switch-disconnector. The actuator mechanism did not give "OFF" position when the contacts were held closed. The position indication complies with the requirements defined in IEC 60947-3, Sub-clause 9.2.6.

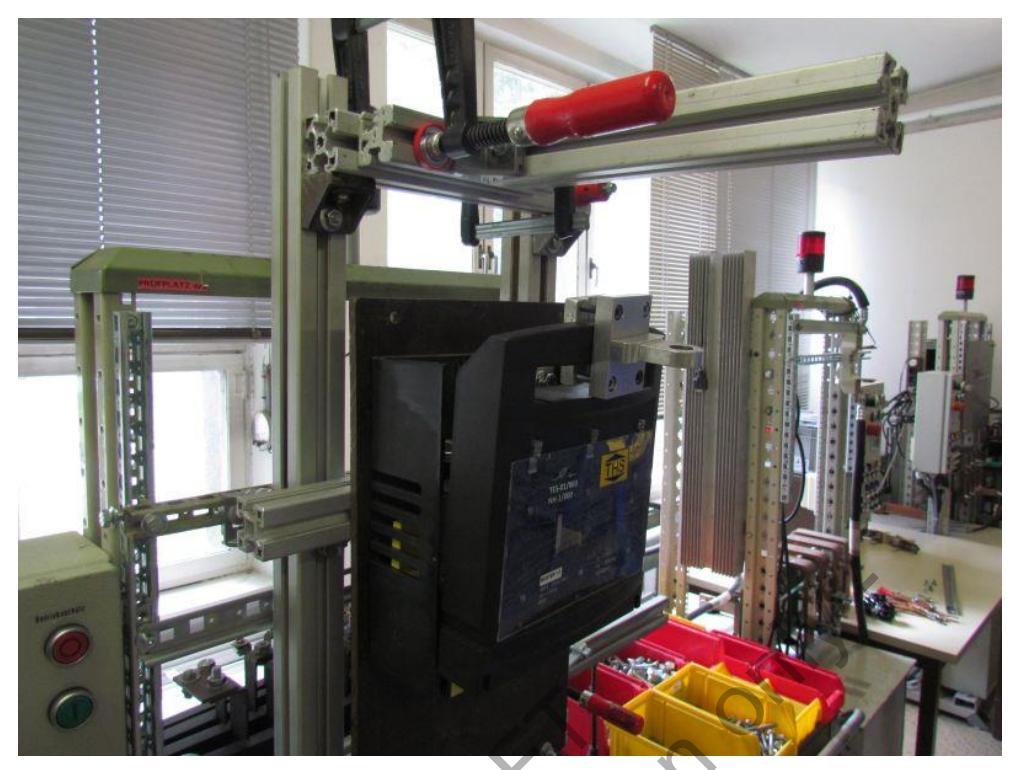
Photo 7: Test object TES-1/800 after the verification of the strength of actuator mechanism

The actuator of TES-1/800 was subjected to the maximum test force of 400 N according to IEC 60947-1, table 17 (one-hand operation). The force was applied without shock to the actuator in a direction to open the contacts for a period of 10 s.

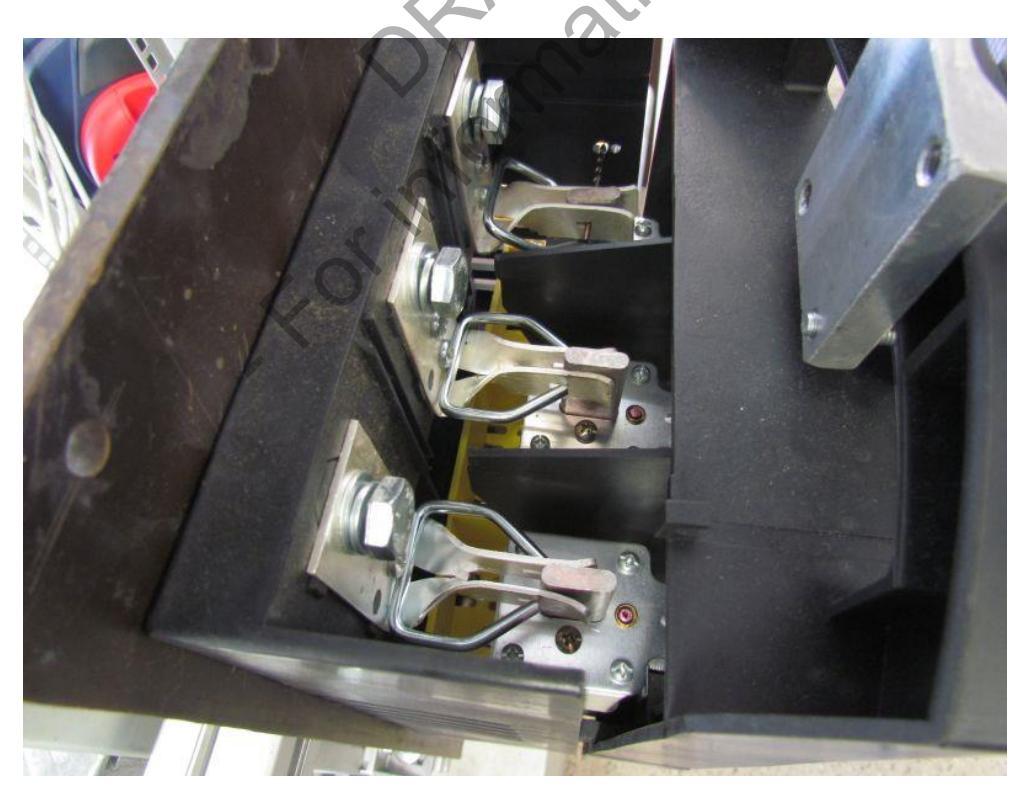
Photo 8: Test object TES-1/800 after the verification of the strength of actuator mechanism

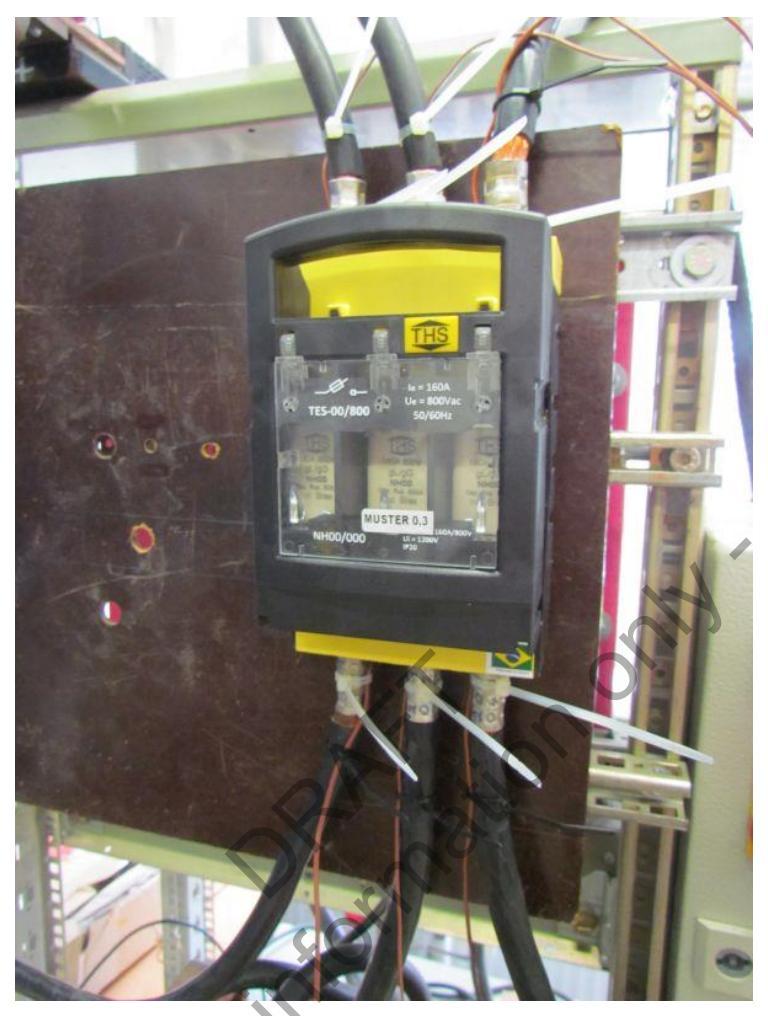
Photo 9: Test object TES-00/800 during temperature-rise verification

The temperature-rise verification was carried out with THS NH00 fuse links (800V, 160A, gL/gG, 50kA, 12W).

The final temperature rise measured did not exceed the permissible temperature-rise limits.

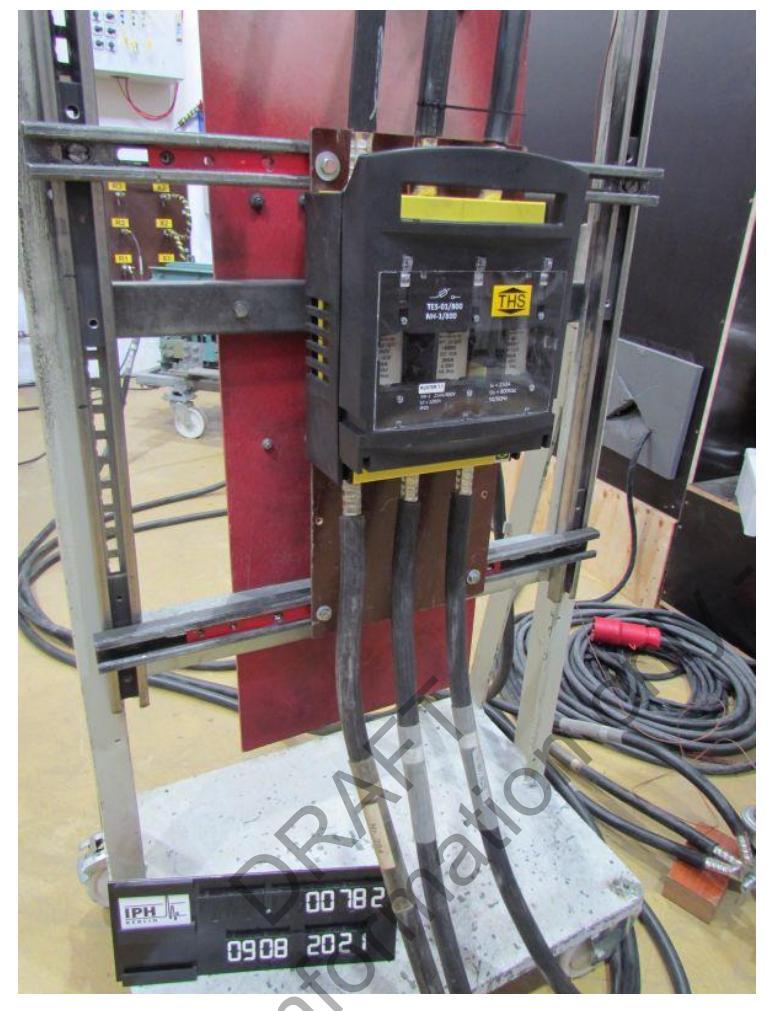
Photo 10: Test object TES-1/800 during temperature-rise verification

The temperature-rise verification was carried out with THS NH1 fuse links (800V, 250A, gL/gG, 50kA, 23W).

The final temperature rise measured did not exceed the permissible temperature-rise limits.

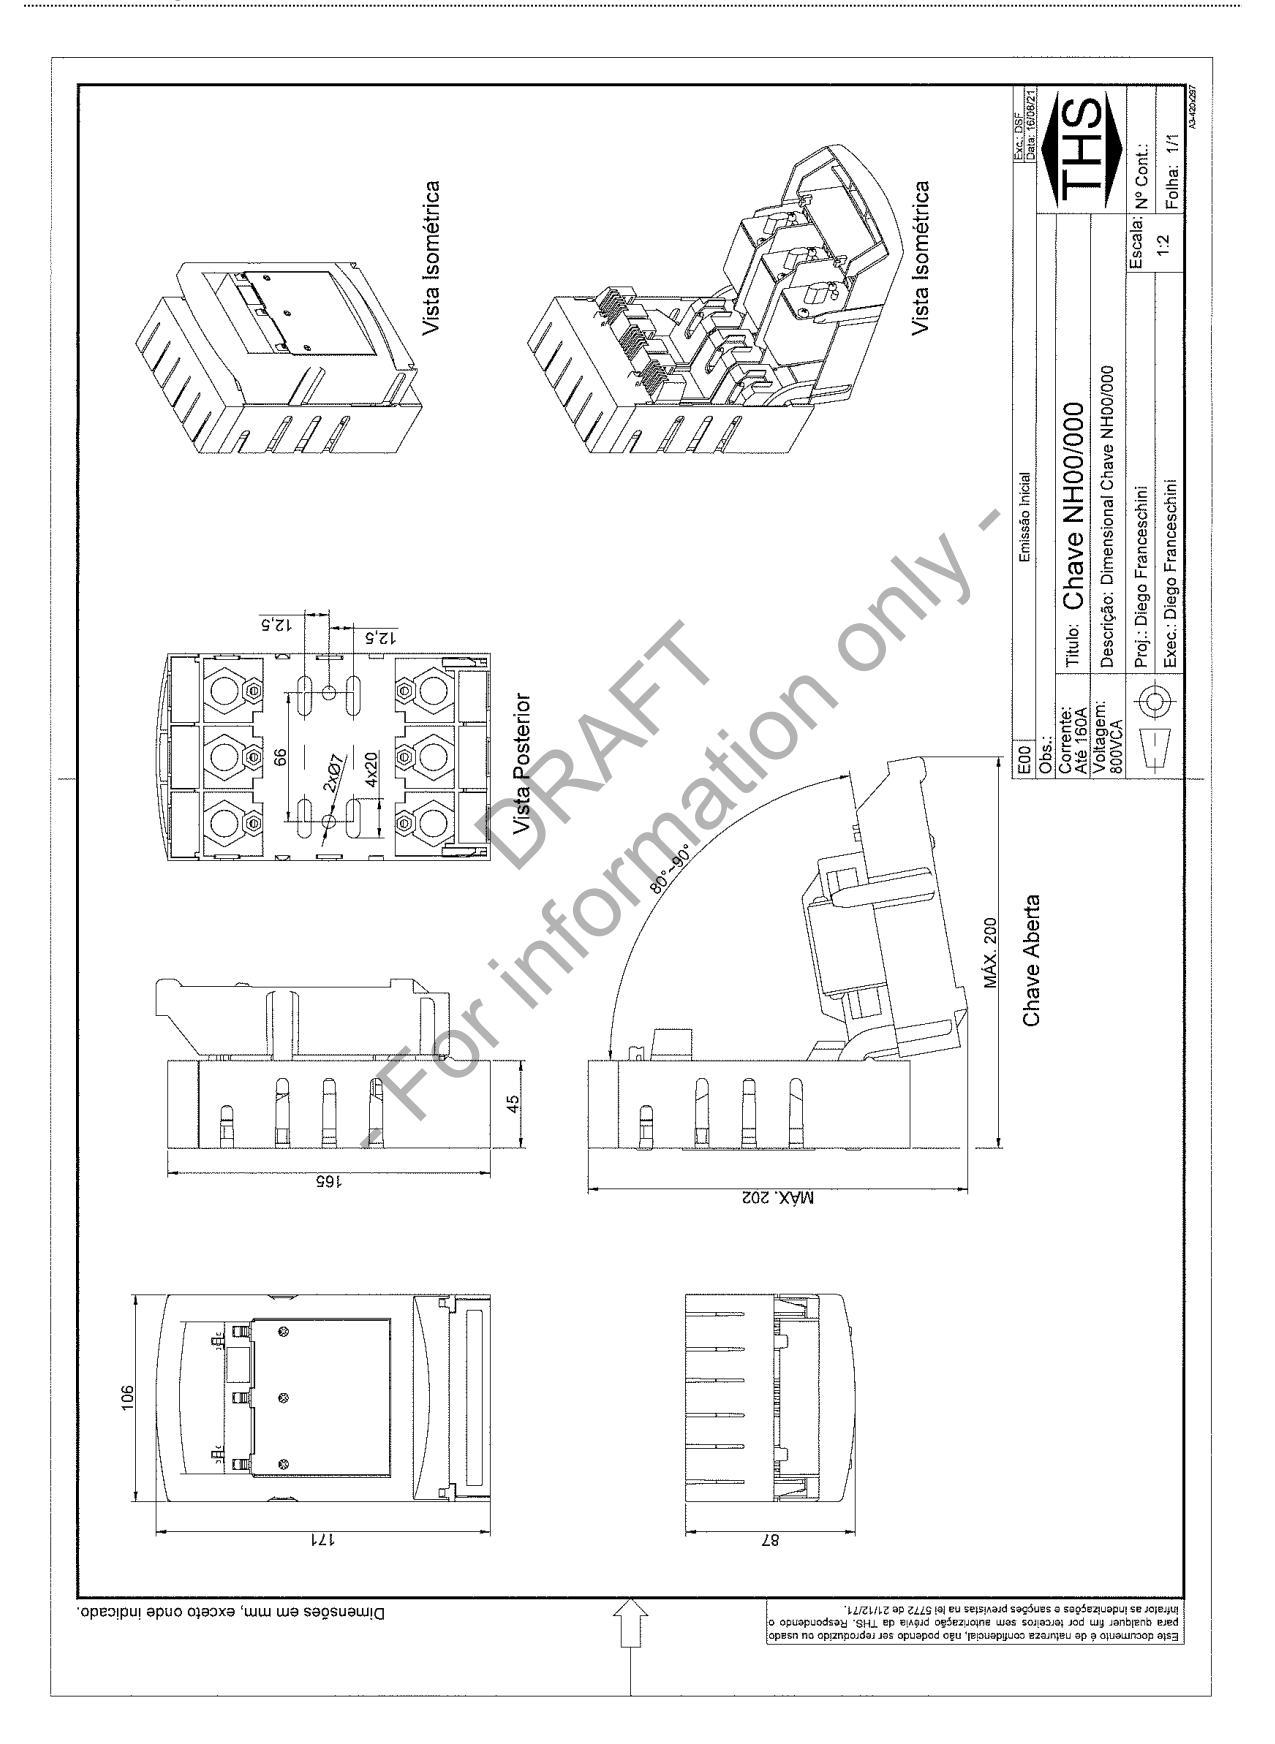
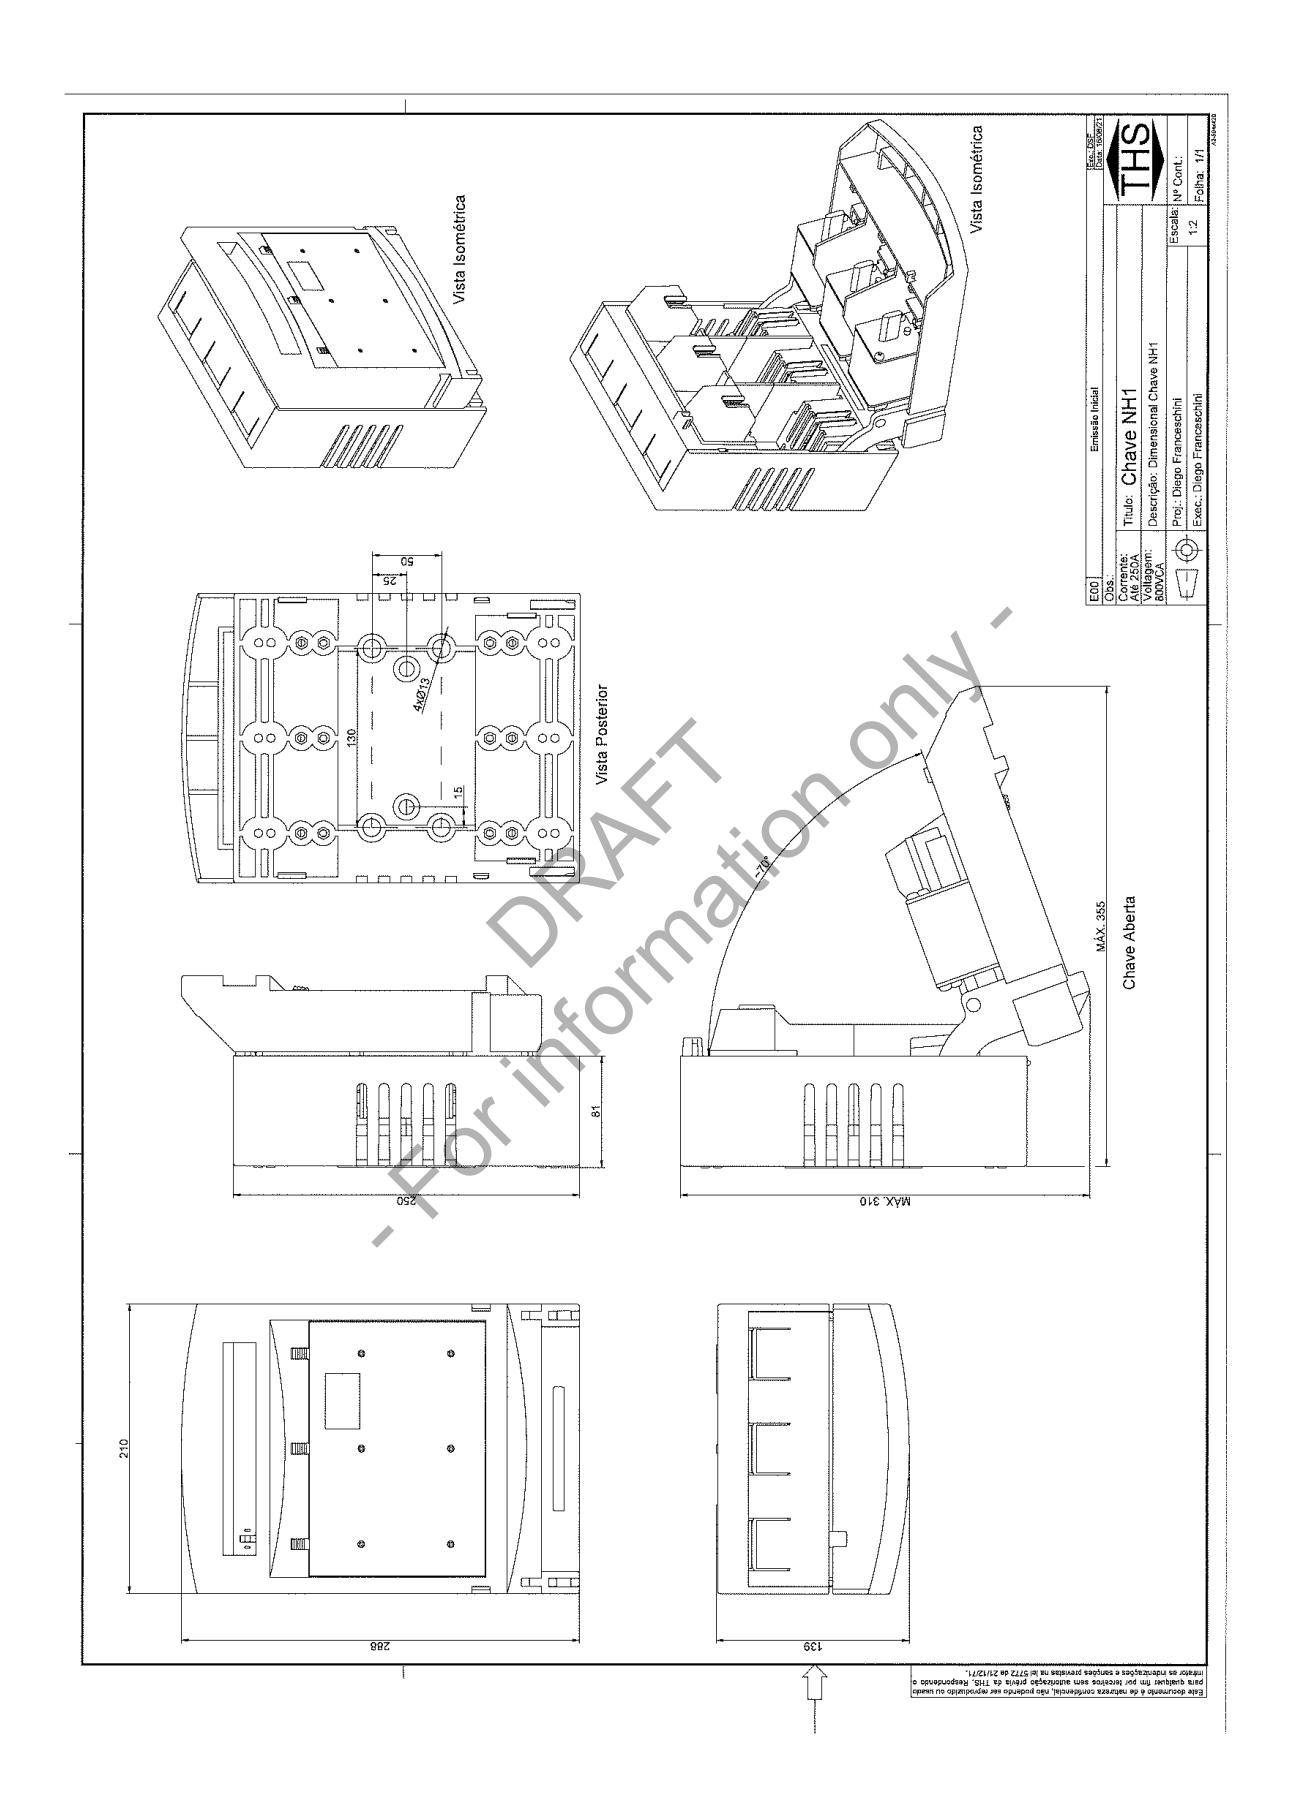
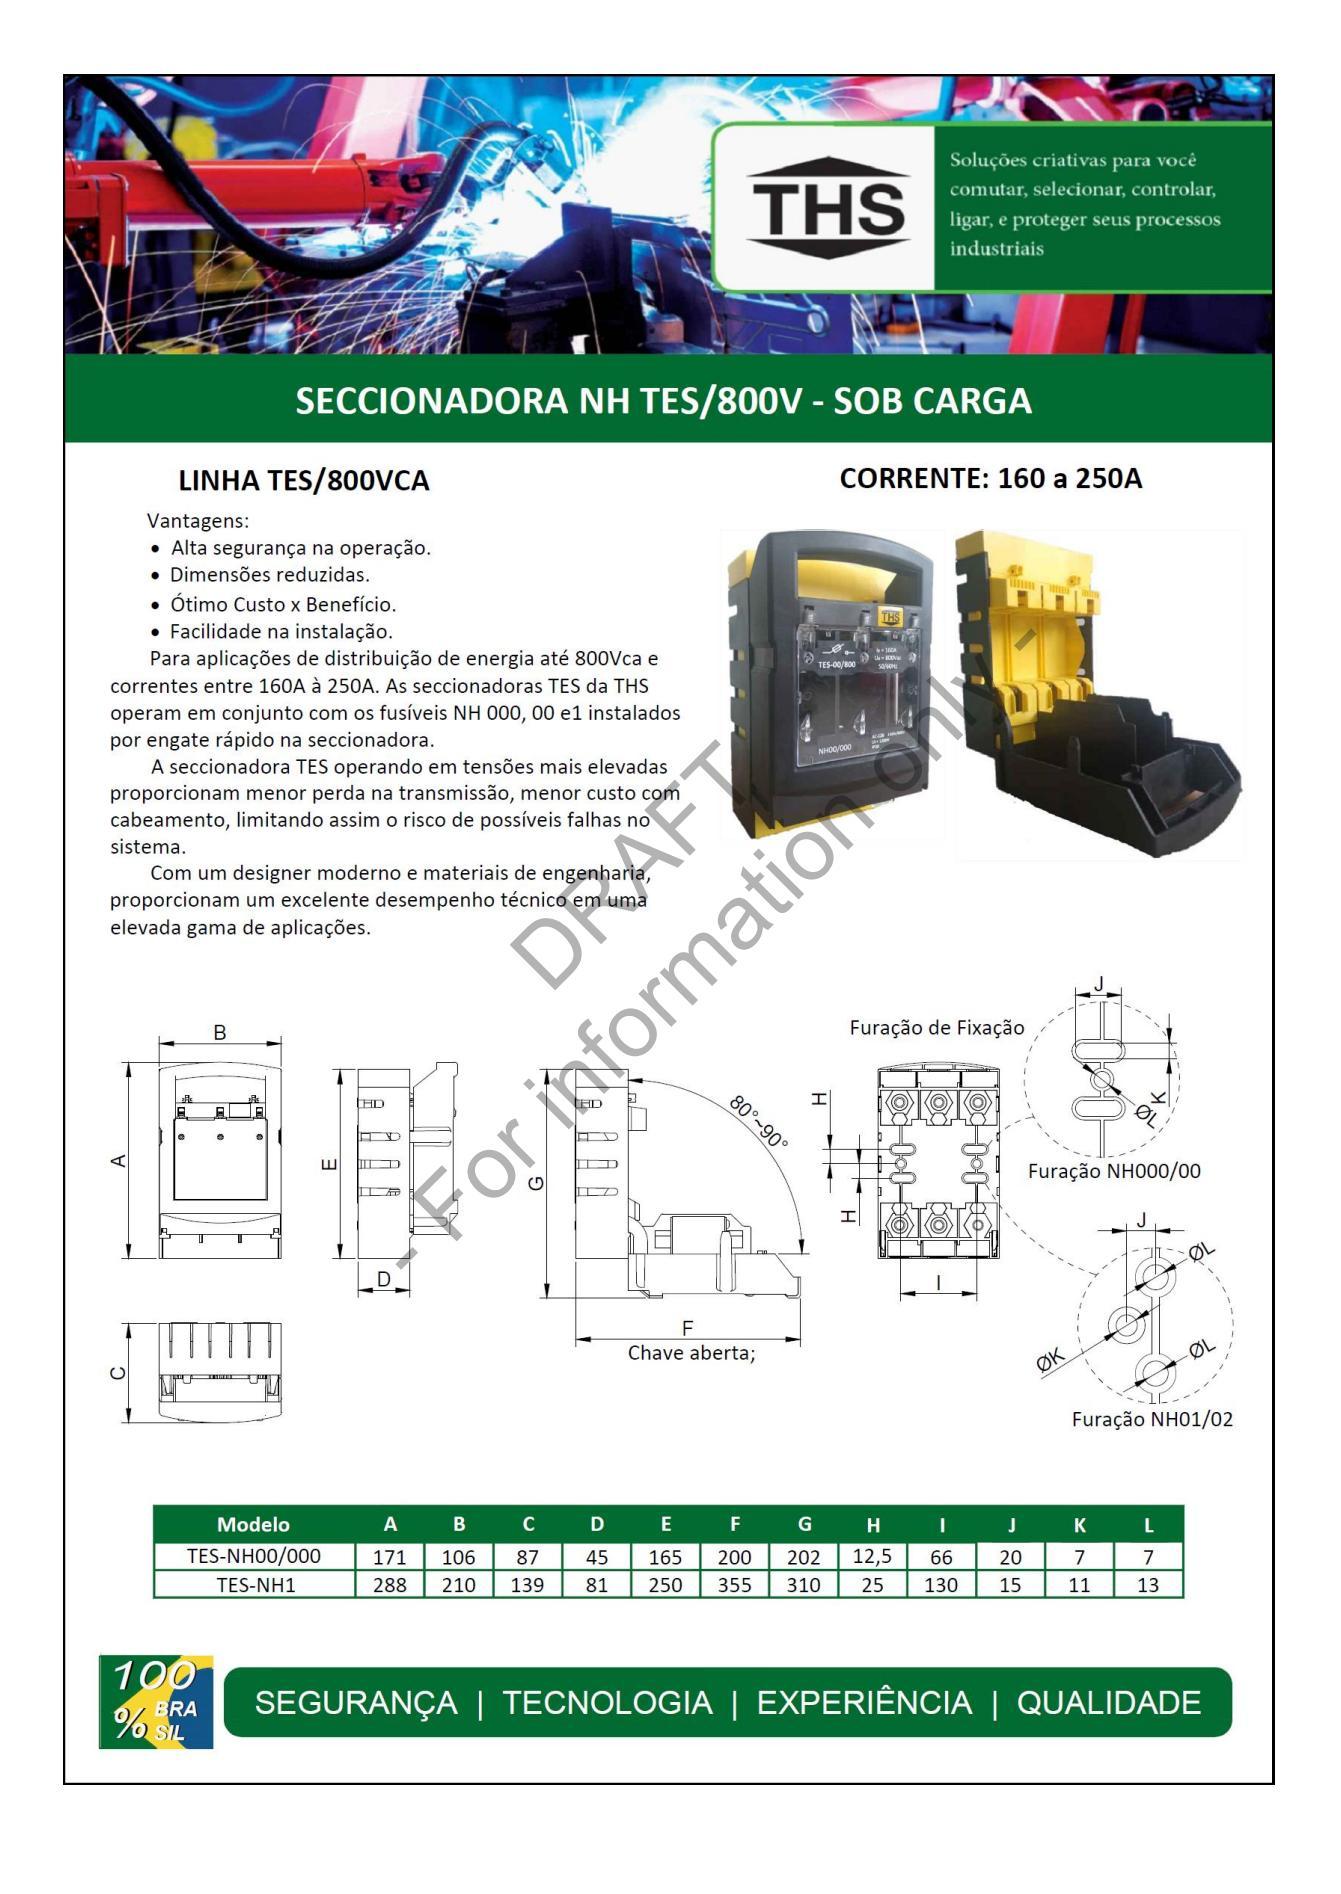
# 7. Drawings

Name of drawing	Drawing No.	Date of drawing	Author	Notes
Chave NH00/000		16/08/21	THS	Sheet 40
Chave NH1		16/08/21	THS	Sheet 41
SECCIONADORA NH TES 800V - SOB CARGA			THS	Sheet 42

The manufacturer confirms that the test object has been manufactured in compliance with the drawings given in this document. IPH did not verify this compliance in detail.
